Evaluation Of The Fused Slurry Silicide Coating Considering Component Design And Reuse

MCDONNELL DOUGLAS ASTRONAUTICS COMPANY • EAST

TECHNICAL REPORT AFML-TR-70-154

December 1970

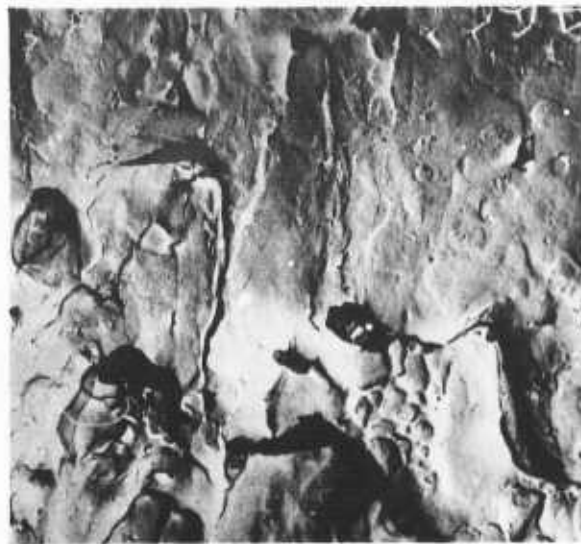
Area A
4200X

Area B
4200X

The microscopic features of the fracture surfaces as observed in the light microscope indicate fracture origin at both edges of Specimen 1 and at one edge of Specimen 2. The remaining areas of both specimens consisted of shear fracture. Electron fractographic examination of Specimen 1 revealed a duplex structure at the origin, Figure 57 Area A. The duplex structure consisted of a mixture of brittle cleavage rupture and ductile dimple rupture. The shear region exhibited elongated dimples typical of a ductile shear rupture, Area B of Figure 57. Both the origin and shear region on Specimen 2 revealed ductile features typical of an overload failure, Figure 58.
